HUMBUG CREEK STUDY MEMORANDUM

**Tetra Tech EM, Inc.
10860 Gold Center Dr, Suite 200
Rancho Cordova, California 95670
(916) 852-8300**

**US Bureau of Land Management
California Abandoned Mine Land Unit
2800 Cottage Way, Suite W-1834
Sacramento, CA 95825-1886
October 2008**

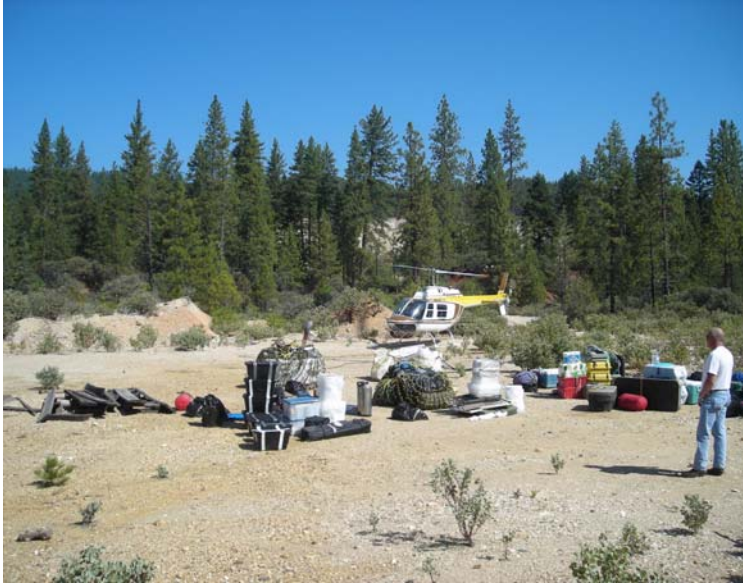
Photograph 1

September 15, 2008. Equipment staging for transport from Crystal Hill to Humbug Creek site. View North.

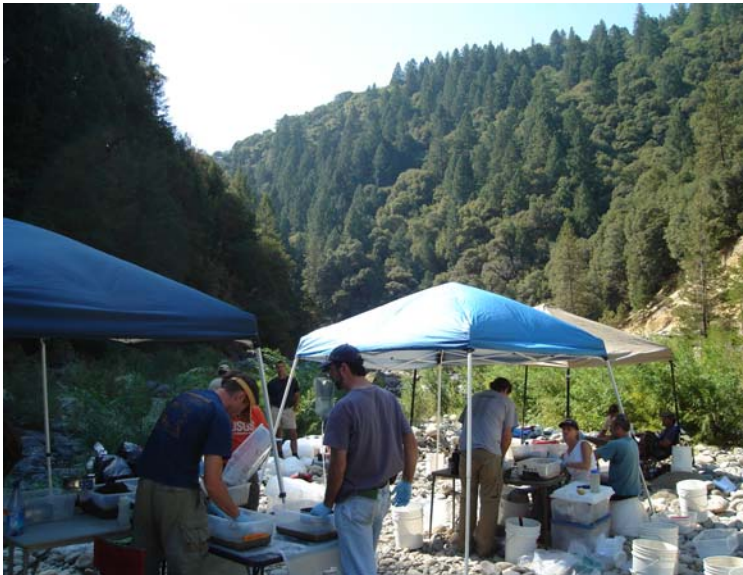
Photograph 2

September 16, 2008. Processing area set up to separate size fractions from test pit excavation. View east.

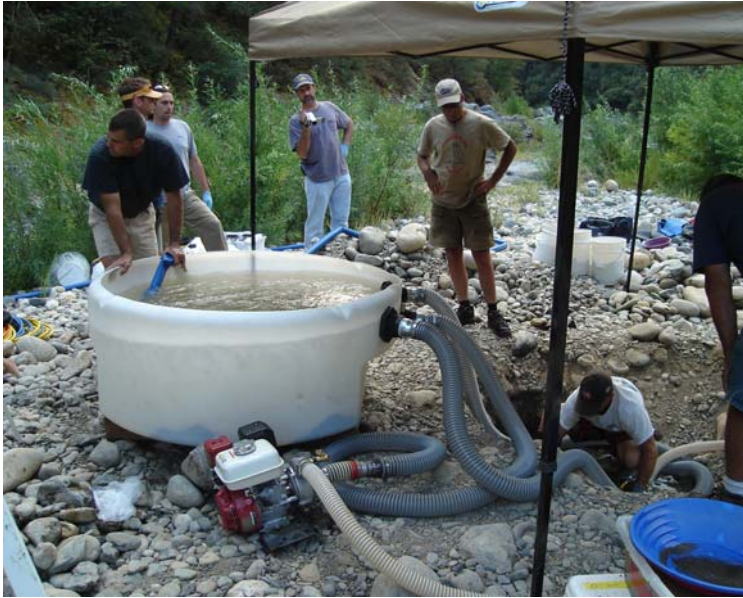
Photograph 3

September 16, 2008. Test for recycling and settling apparatus used by Pro-Mack. View south..

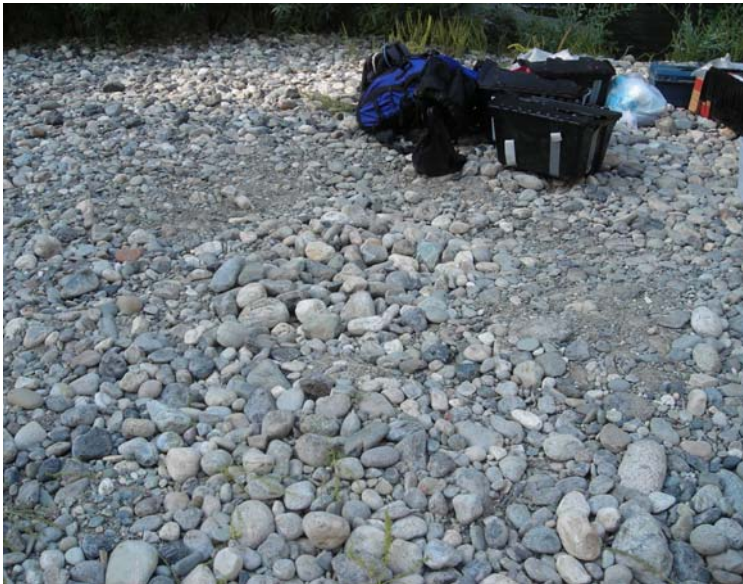
Photograph 4

September 16, 2008. View of first test pit on gravel bar after it was back filled. View southwest.

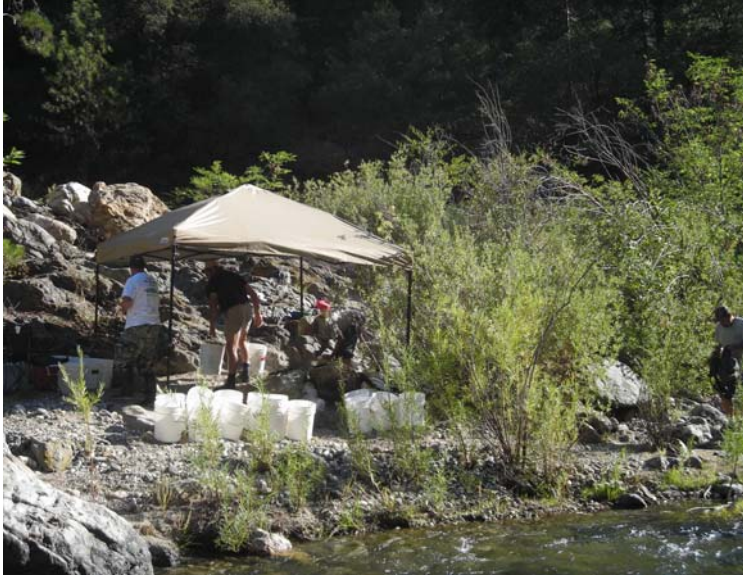
Photograph 4

September 17, 2008. View of second test pit on north bank of South Yuba River just downstream of Humbug Creek confluence. View northeast.

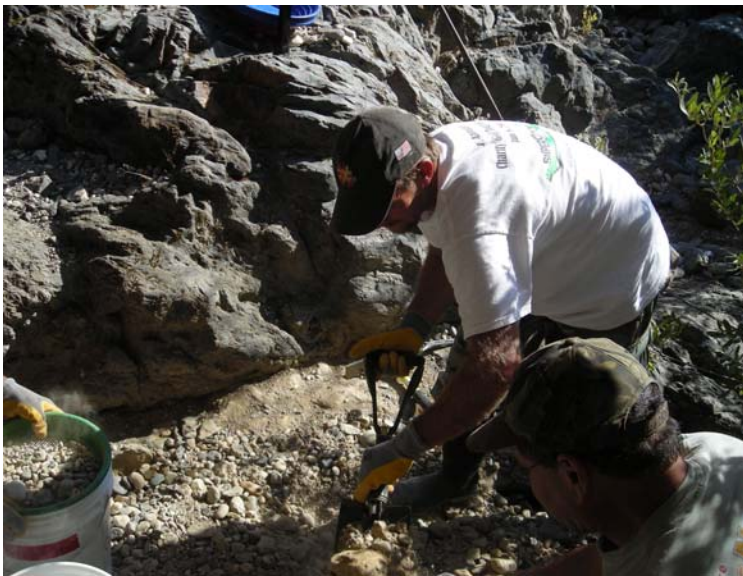
Photograph 5

September 17, 2008. Pro-Mack personnel excavating at second test pit. View north.

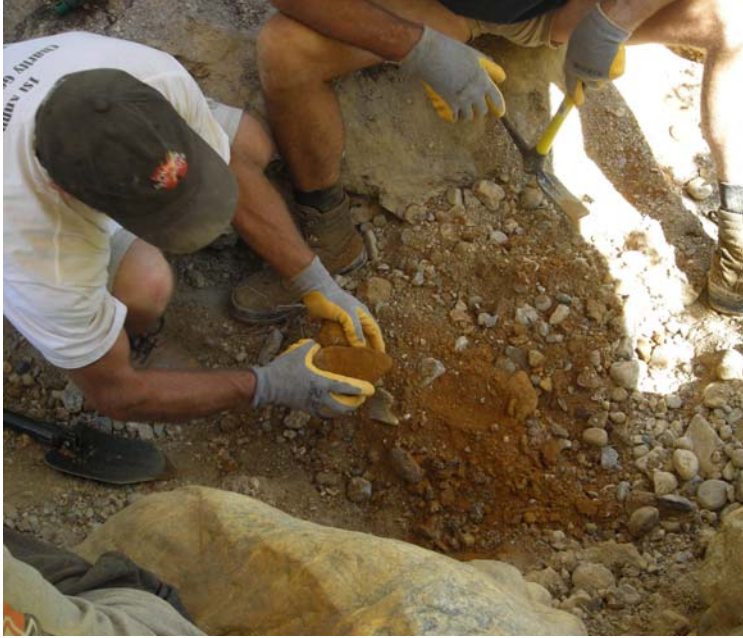
Photograph 6

September 17, 2008. Pro-Mack personnel excavating at second test pit. Note orange color due to iron oxidation. View down.

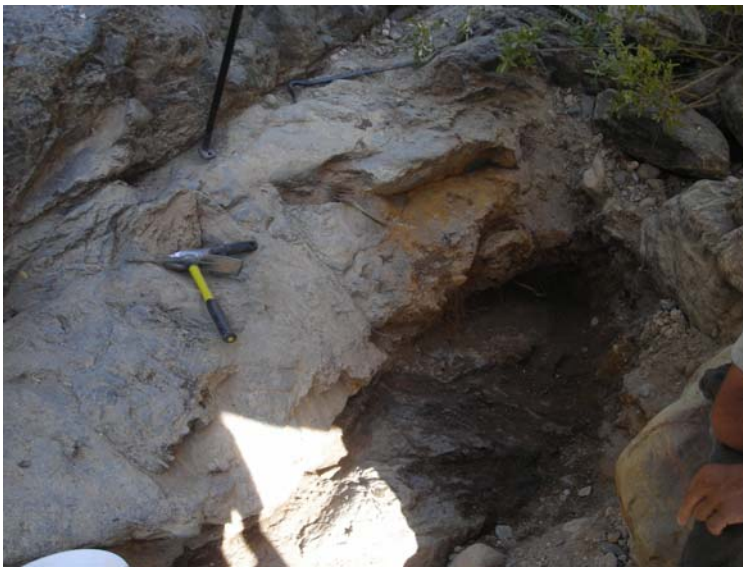
Photograph 7

September 17, 2008. View of second test pit after excavation. Note bare bedrock was reached and cleaned. View northeast.

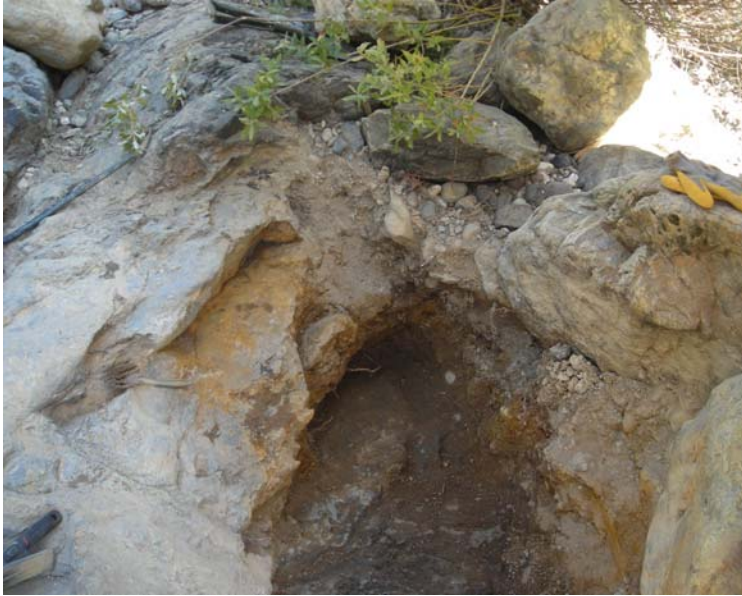
Photograph 8

September 17, 2008. View of second test pit after excavation. Note bare bedrock was reached and cleaned. View north.

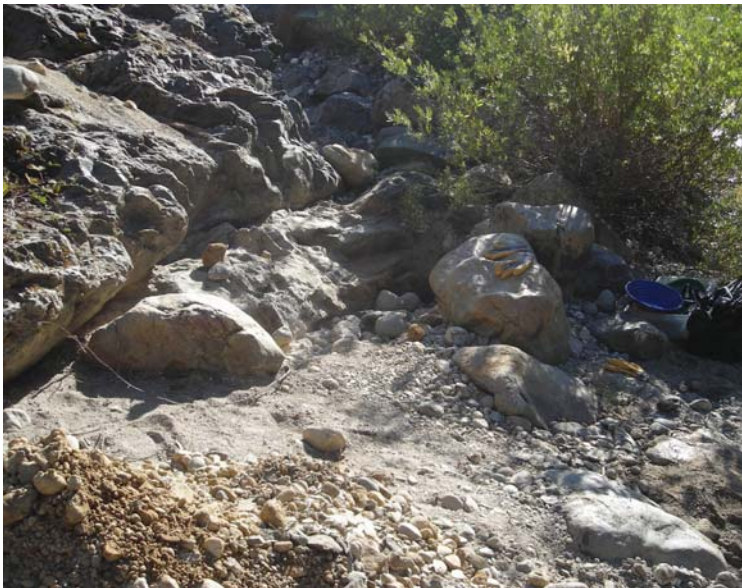
Photograph 8

September 17, 2008. View of second test pit after it was backfilled. View northeast.

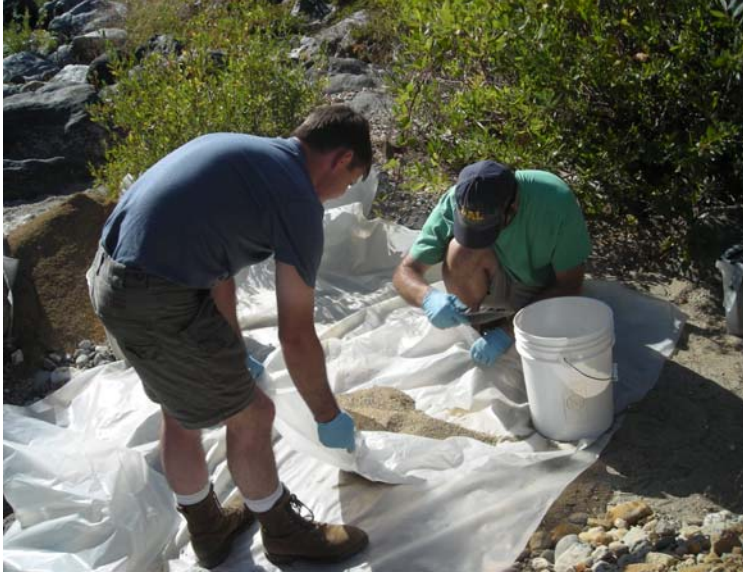
Photograph 9

September 17, 2008. USGS personnel compositing second test pit samples. View southwest.

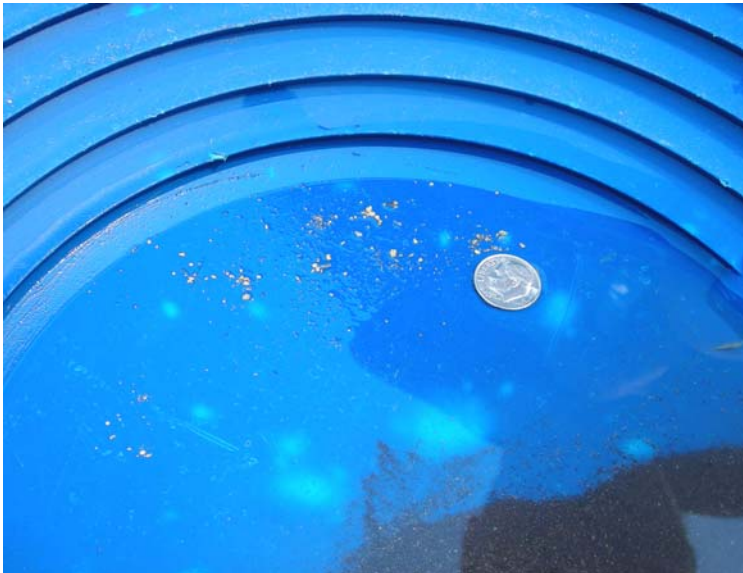
Photograph 10

September 18, 2008. Pannings from spot tests. Note substantial stained gold but minimal free mercury. View down.

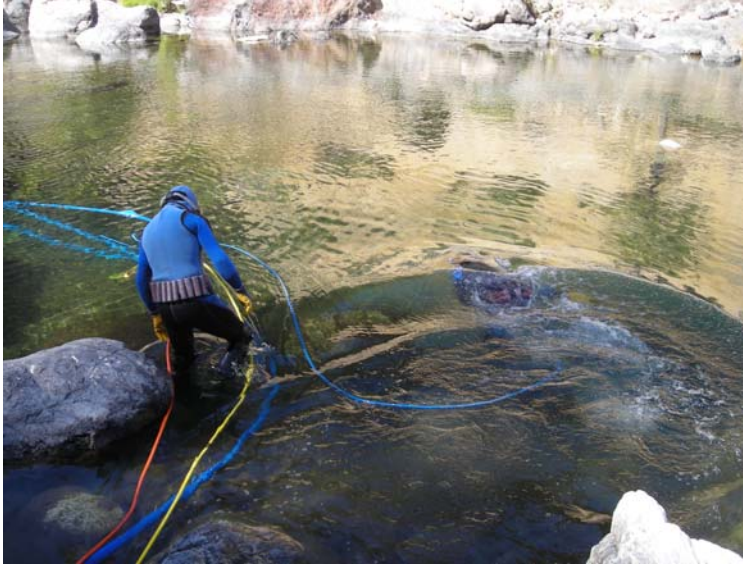
Photograph 11

September 18, 2008. Pro-Mack crew spot conducting spot tests in middle of South Yuba River downstream of Humbug Creek. Minimal free mercury was found in this area where previous dredgers have claimed to find upwards of 20 pound pools of free mercury. View northwest.
