# HUMBUG CREEK STUDY MEMORANDUM

**US Bureau of Land Management  
California Abandoned Mine Land Unit  
2800 Cottage Way, Suite W-1834  
Sacramento, CA 95825-1886  
October 2008**

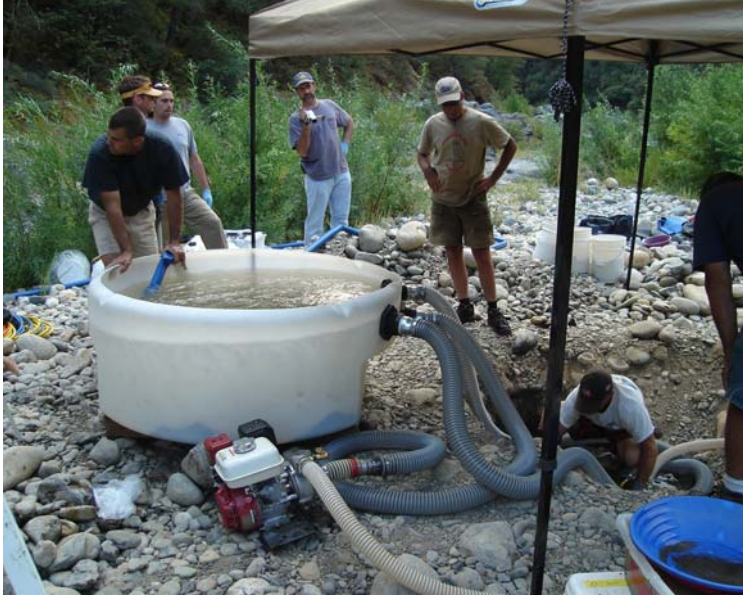
**Photograph 3**

September 16, 2008. Test for recycling and settling apparatus used by Pro-Mack. View south..

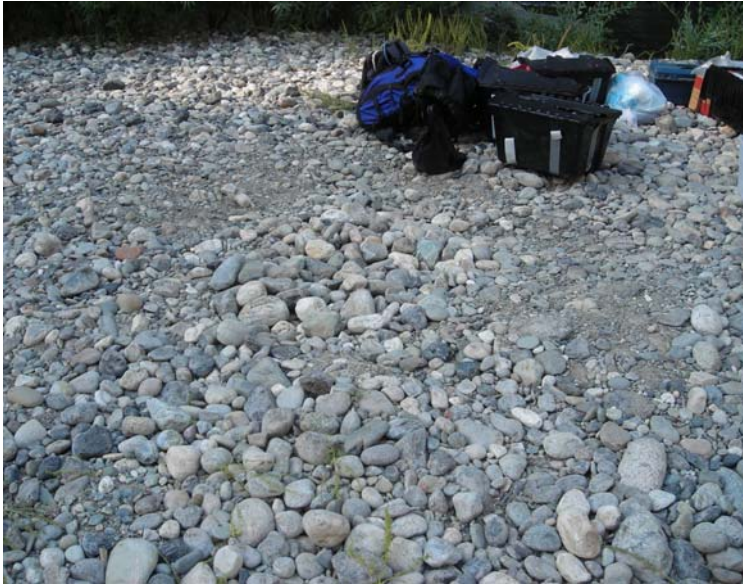
**Photograph 4**

September 16, 2008. View of first test pit on gravel bar after it was back filled. View southwest.

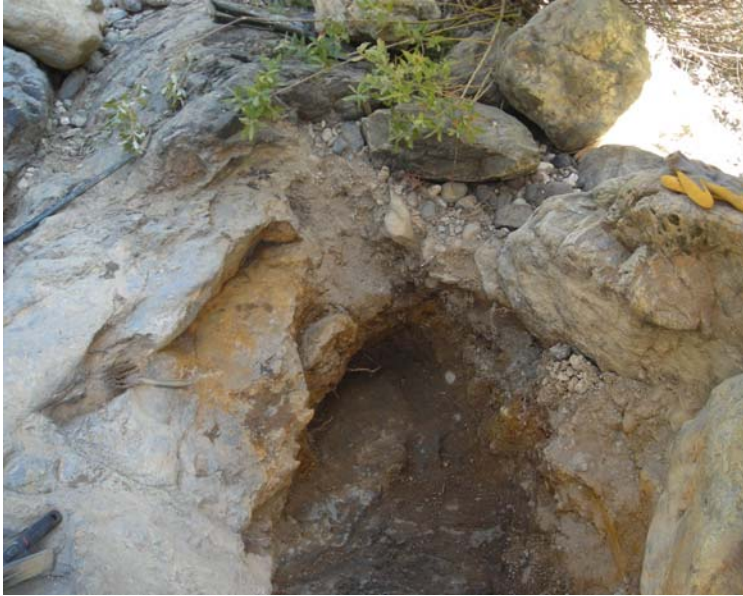
**Photograph 8**

September 17, 2008. View of second test pit after excavation. Note bare bedrock was reached and cleaned. View north.

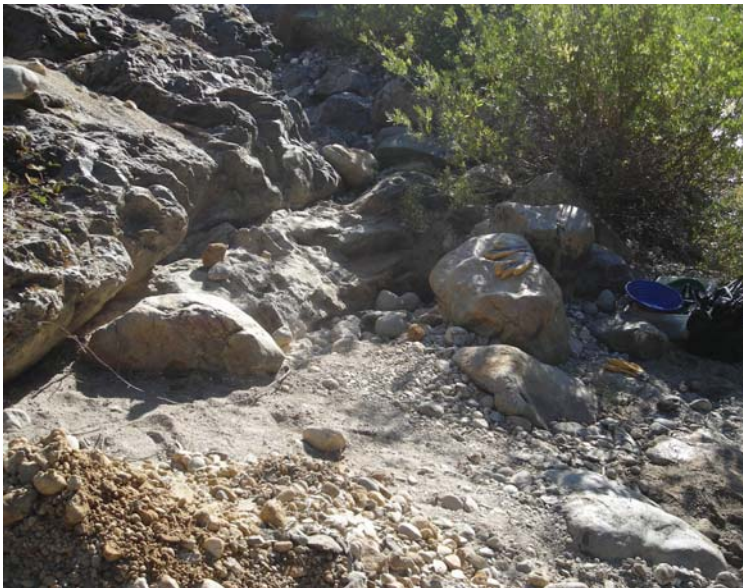
**Photograph 8**

September 17, 2008. View of second test pit after it was backfilled. View northeast.
